Weekly Update

Sept 11 – 17

Repair Work

Devil's Slide (post mile 39.14)

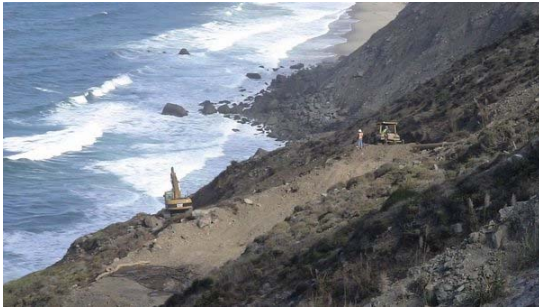
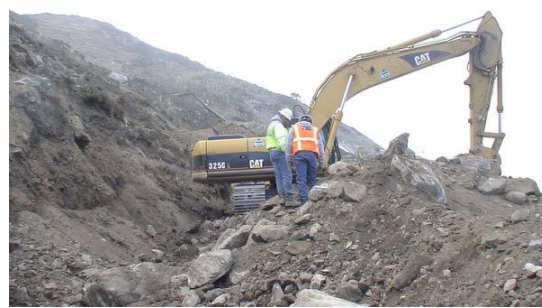
- Excavation work got underway to provide temporary access for the work needed to extend the drain pipe below the road. This will allow all drain water to be discharged close to the ocean and eliminate the potential of erosion from this source.

Excavator and bulldozer at work to create access for drain the extension

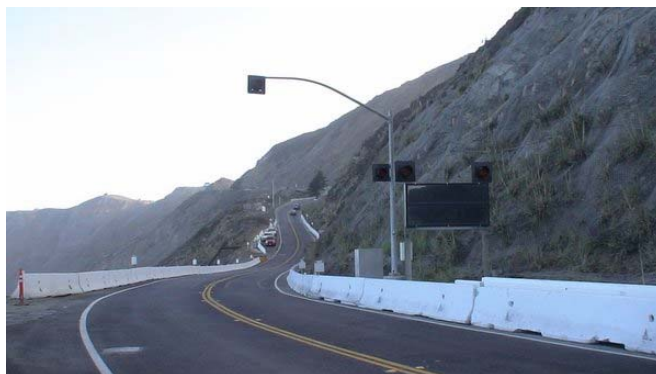
- The slide movement sensor system was inspected by Caltrans Signal Operations group this week. A thorough inspection of sensors, wiring and electrical components was undertaken. Some components remain on backorder.

New emergency message sign and signals

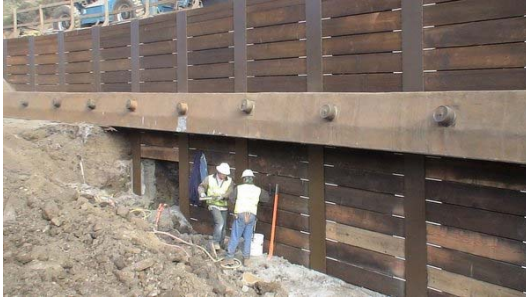
- Excavating and lagging the last 7 feet of the retaining wall was completed this week. The steel beams were painted to blend in and match the wood lagging.

Partial excavation at the wall base

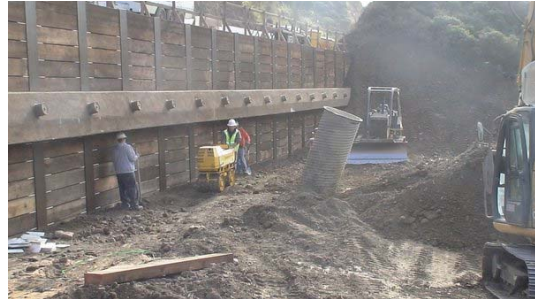
Compacting earth at the bottom of the wall
